**DEPARTMENT OF TRANSPORTATION**

Contract #: 04-0120F4Cty: SF/ALA Rte: 80 PM: 13.2/13.9File #: 69.28**WELDING INSPECTION REPORT****Resident Engineer:** Siegenthaler, Peter**Address:** 333 Burma Road**City:** Oakland, CA 94607**Report No:** WIR-020467**Date Inspected:** 26-Jan-2011**Project Name:** SAS Superstructure**OSM Arrival Time:** 700**Prime Contractor:** American Bridge/Fluor Enterprises, a JV**OSM Departure Time:** 1900**Contractor:** Zhenhua Port Machinery Company, Ltd (ZPMC), Changxing Island **Location:** Shanghai, China**CWI Name:** Xu Le Feng**CWI Present:** Yes No**Inspected CWI report:** Yes No N/A**Rod Oven in Use:** Yes No N/A**Electrode to specification:** Yes No N/A**Weld Procedures Followed:** Yes No N/A**Qualified Welders:** Yes No N/A**Verified Joint Fit-up:** Yes No N/A**Approved Drawings:** Yes No N/A**Approved WPS:** Yes No N/A**Delayed / Cancelled:** Yes No N/A**Bridge No:** 34-0006**Component:** OBG Components**Summary of Items Observed:**

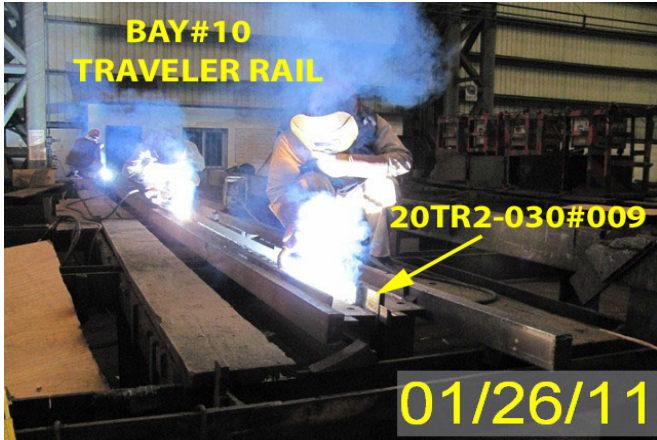
Repair welding of a weld joint # 09 located on Traveler rail 20TR2-030 as per the weld repair report #

B-WR14292. Welder is identified as 044473. ZPMC Quality Control (QC) Inspector is identified as Li Jun. The

welding variables recorded by QC appeared to comply with the WPS – 345 – FCAW – 1G (1F) – ESAB – REPAIR. (See attached photo)

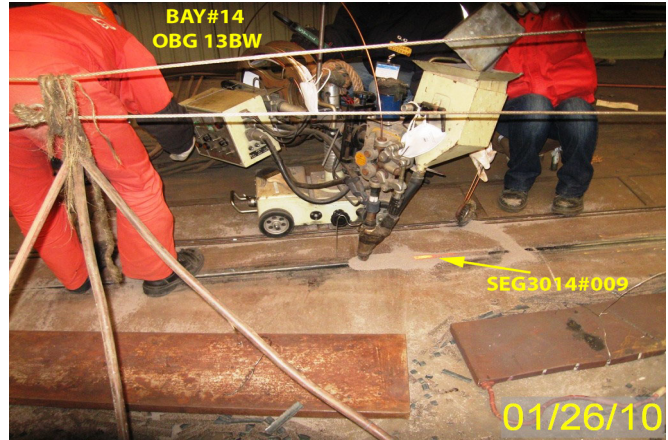
Weld joint #009 located on 13BW, SEG3014. Welder is identified as 045270. ZPMC Quality Control (QC) Inspector is identified as Sun Tian Liang. The welding variables recorded by QC appeared to comply with the WPS-B-T-223(2)1T-ESAB-1. (See attached photo)
